CHICOPEE FALLS
LOCAL PROTECTION PROJECT
SPECIAL STUDY
OF
RAILROAD EMBANKMENT

PREPARED FOR
U.S. ARMY ENGINEER DIVISION
NEW ENGLAND

OCTOBER, 1962

By
GREEN ENGINEERING AFFILIATES, INC.
BOSTON MASSACHUSETTS

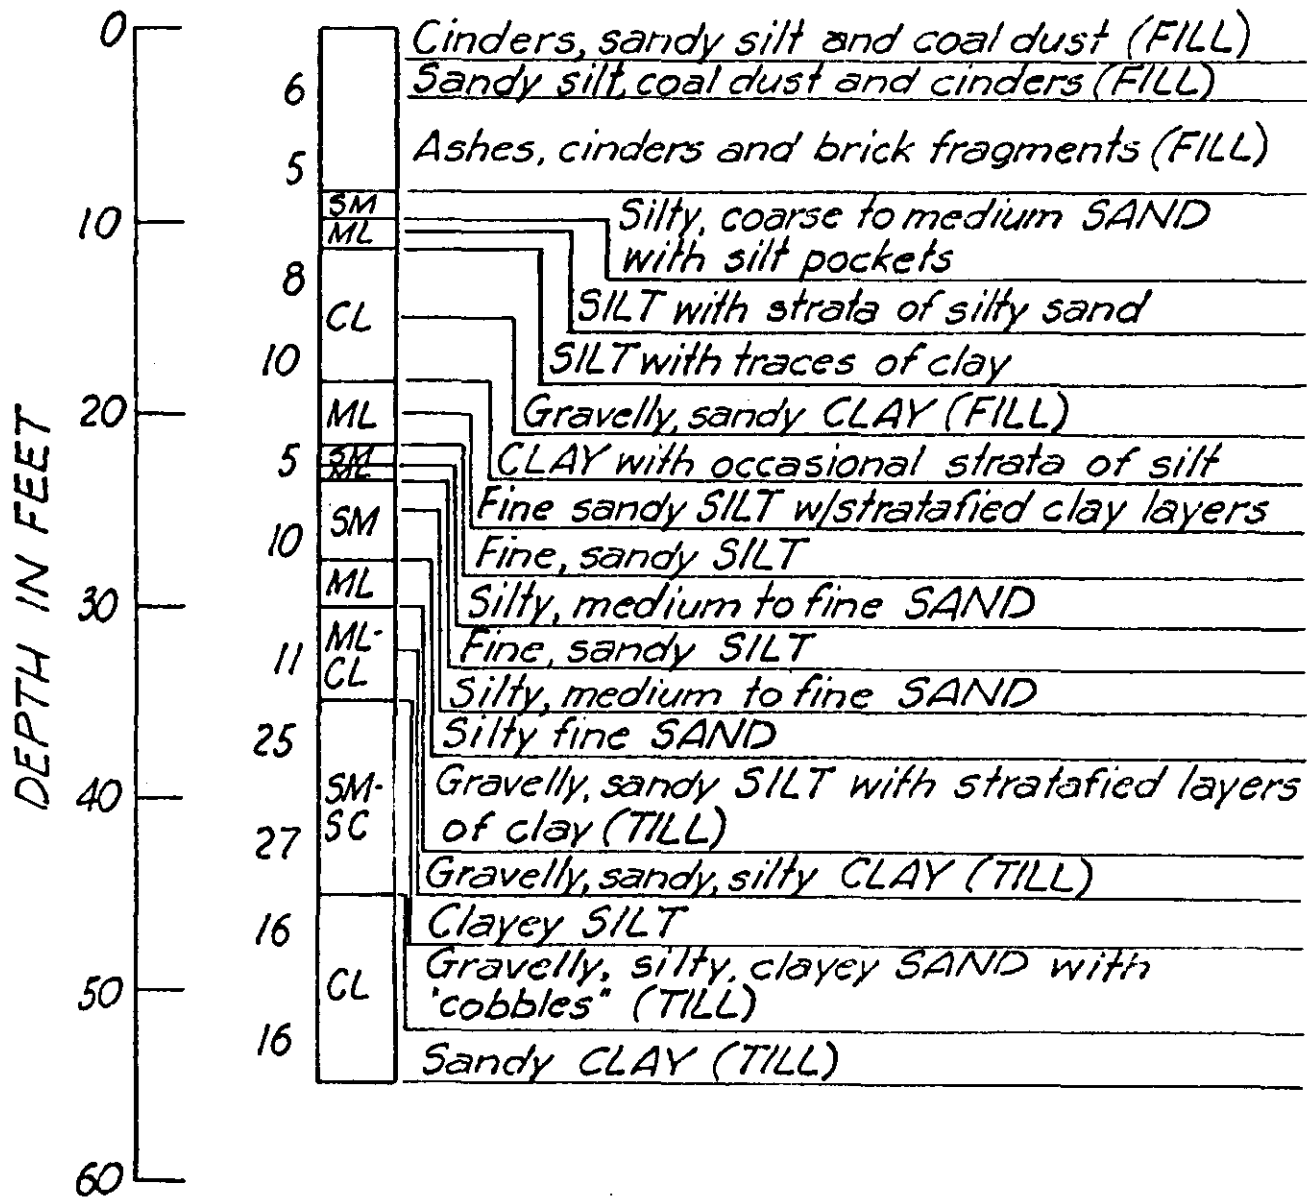
BH-40
14 AUG 1962
E1. 104.5

Laboratory tests on samples of this material from Borings 40 and 42 indicate the liquid limit to be 31 and 35 and the plastic limit to be 27 and 26, respectively. The natural water contents were close to the liquid limits.

A. Soft Material In the Track Fill - As noted on the logs of BH-40 and BH-45 there is a layer of soft silty clay at depths of 1.5 to 3.5 feet below the railroad tracks. This material has a low bearing capacity and is considered unacceptable at shallow depths below the ballast. The fact that this material apparently remains in a moist condition due to surface runoff (discussed in "C" below) increases the problem. It is quite probable that the presence of this soft silty clay contributes to settlement and to weaving under rail traffic due to its proximity to the surface.

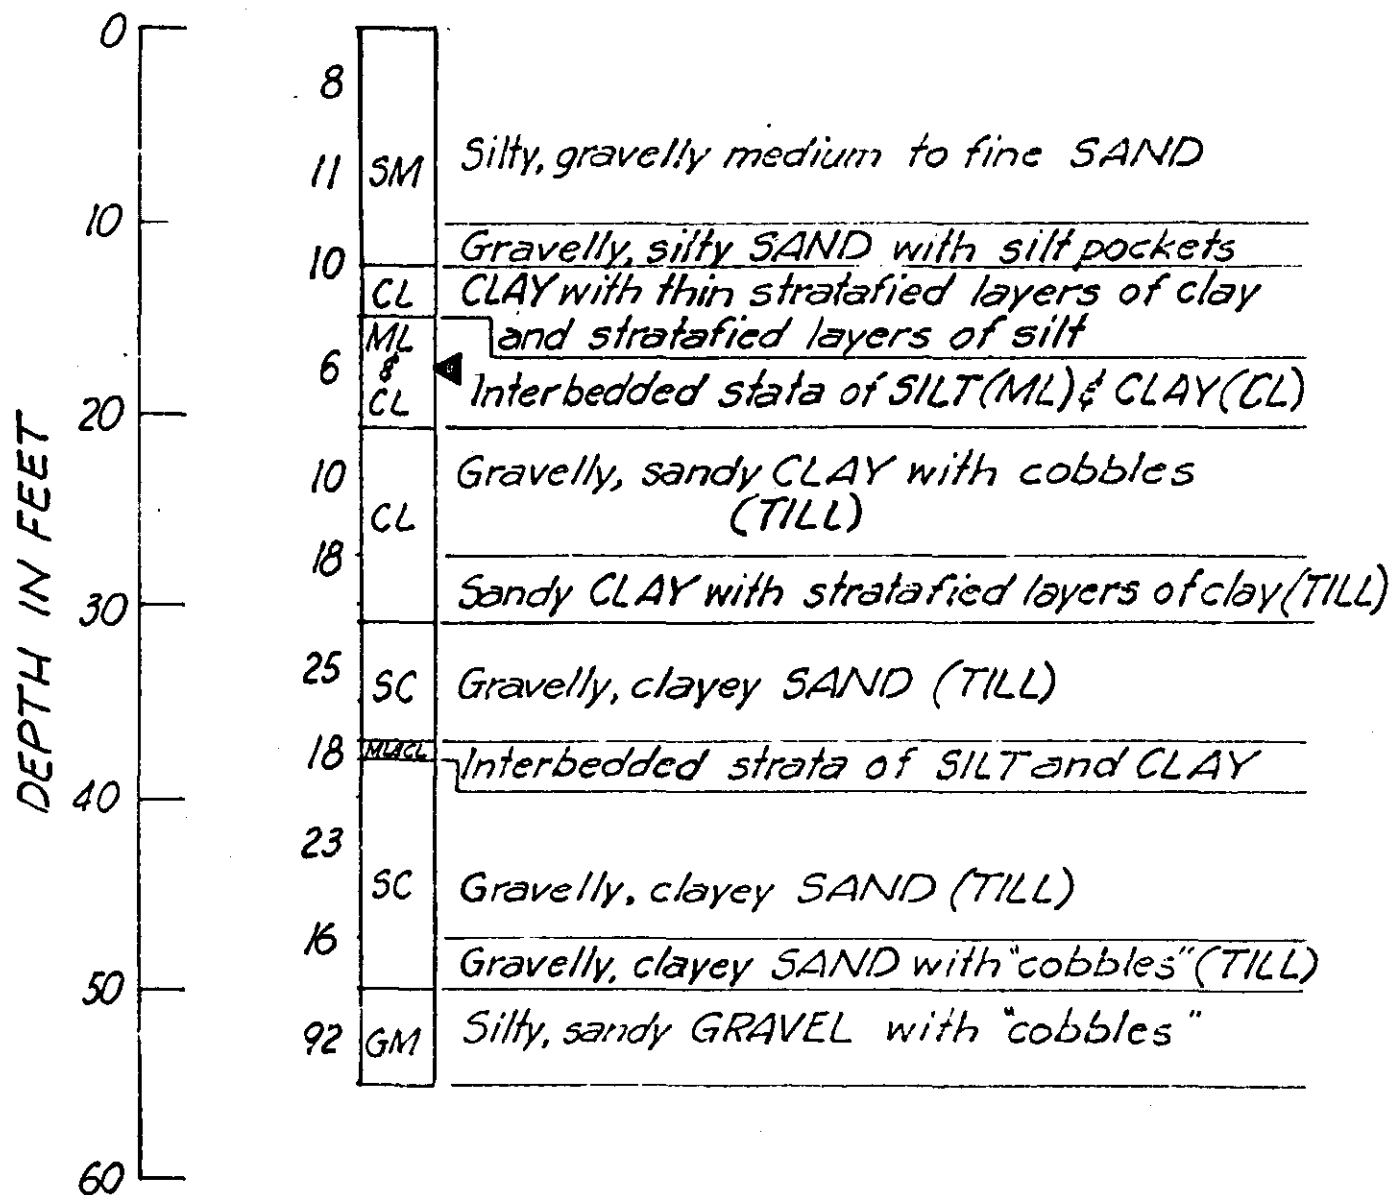
BH- 42
16 Aug 1962
El. 103.5

The actual limits of such material in the fill are not easily detectable. Samples obtained in the fill from BH-42 did not contain soft clay, which may mean that there is not an extensive layer underlying the tracks. A series of shallow borings or hand auger holes would be necessary to check this problem further.

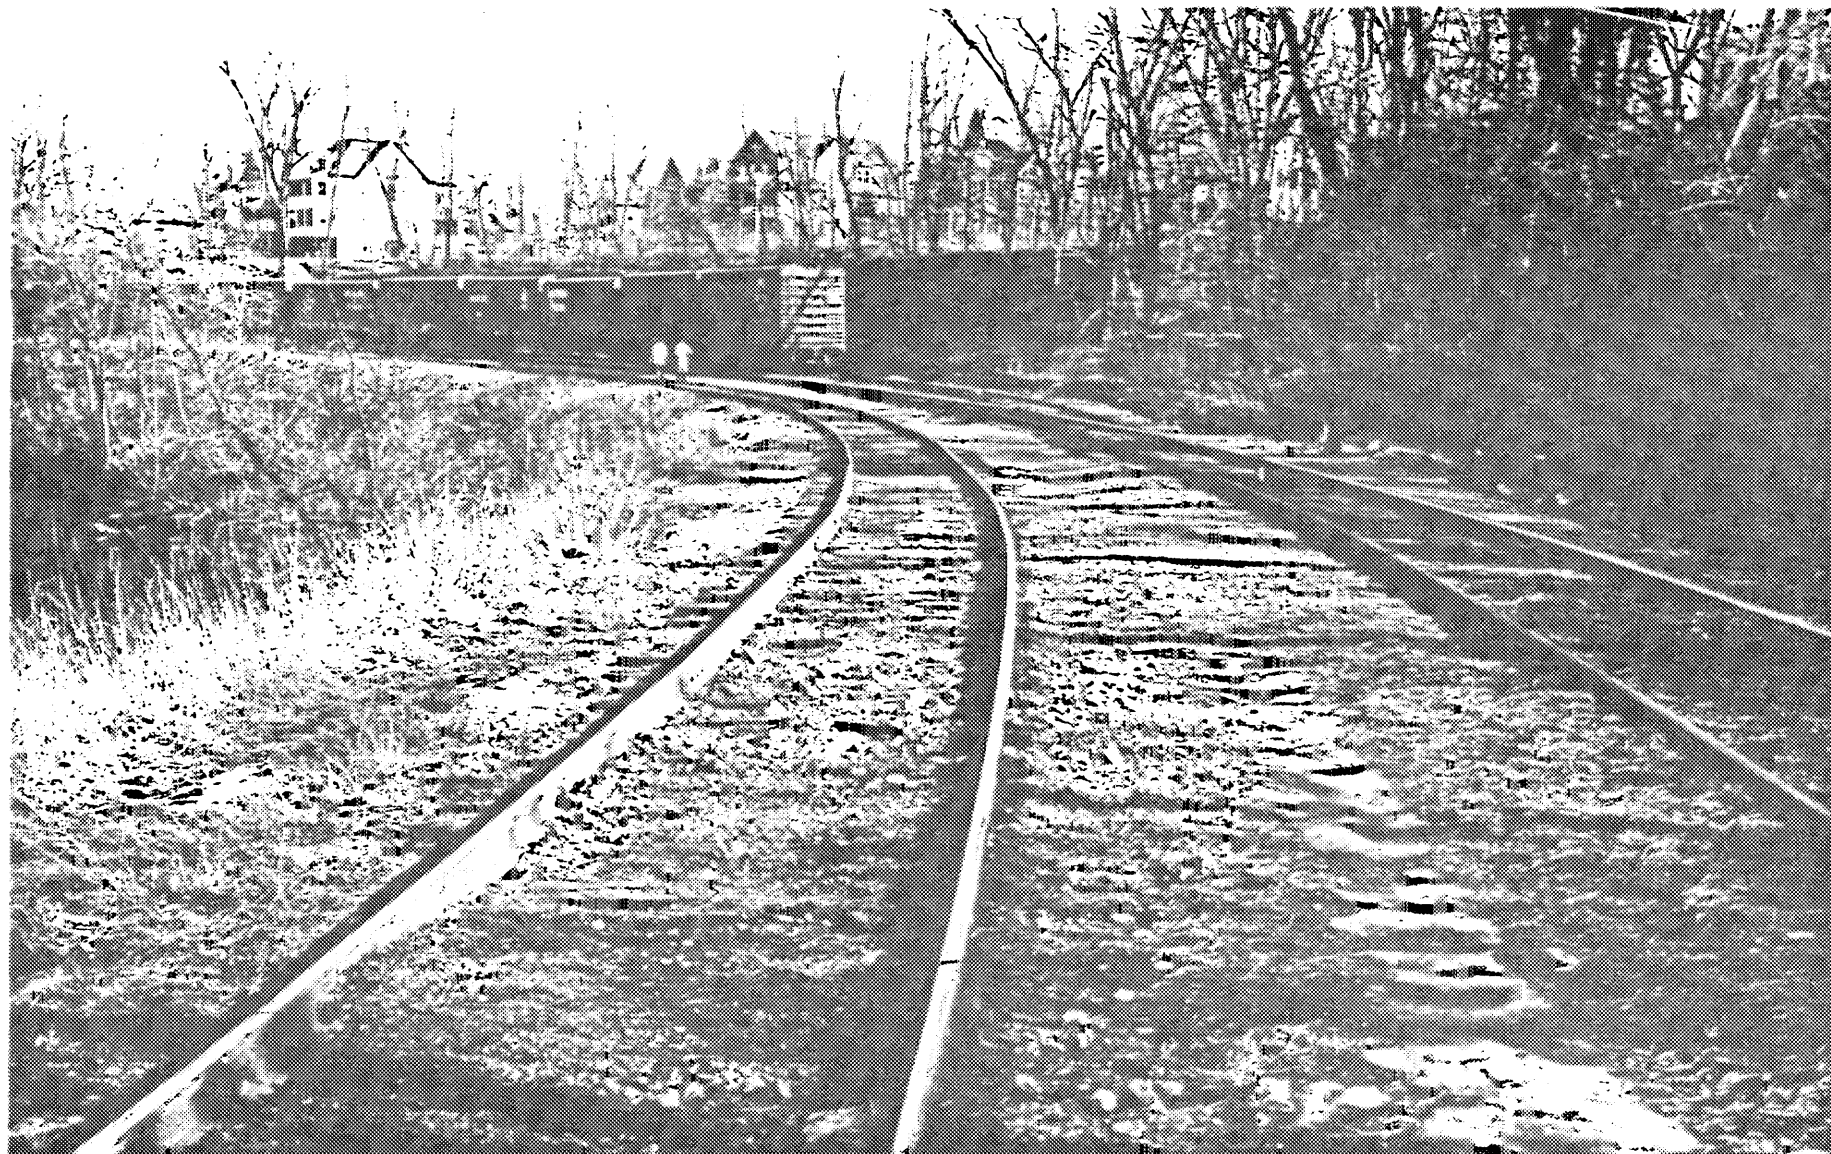
PLATE NO. II

A. Surface Conditions - The railroad embankment slope in the vicinity of the sharpest curvature of the river has been the greatest problem area. Loose rock, varying in size up to approximately 30 inches maximum, has been dumped over the slope for a distance of approximately 150 lineal feet along the river in the vicinity of Section A-A, Plate 4. In this zone, the height of slope is approximately 30 feet and the slope is as steep as 1 on 1-1/4. Most of the rock has fallen to the lower half of the slope. There are no trees, and only occasional low bushes growing in this area. Further upstream, there is evidence of dumped rock, mostly at the toe of the slope, with trees and underbrush becoming quite thick. There are several reaches where fairly recent bank erosion has stripped the vegetation and partially undercut the slope, leaving some portions standing steeper than 1 on 1.

Local Protection Project, Chicopee Falls, Mass.
Condition of Railroad, Looking Upstream from River Section 62+
Date: January 24, 1962

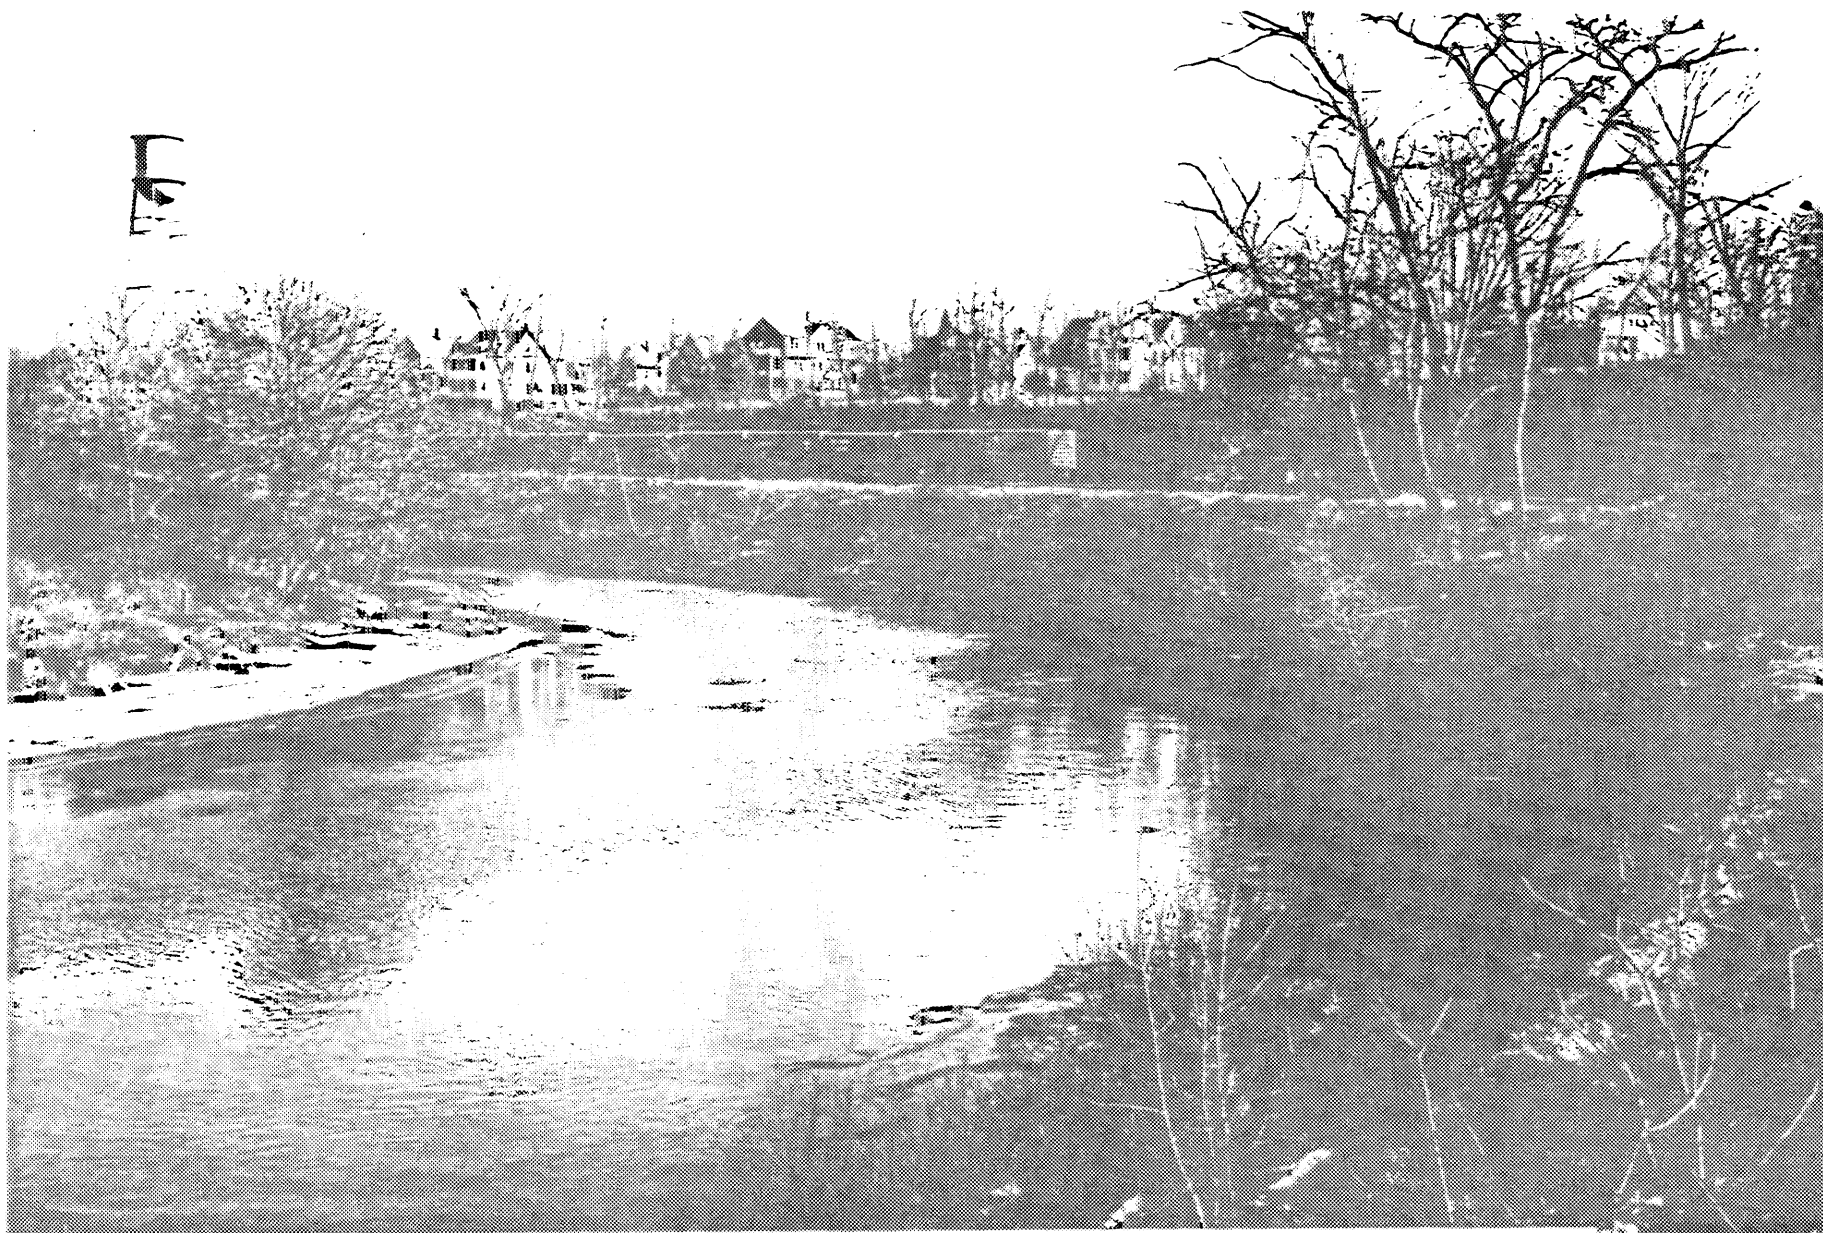
PLATE NO. 12

Local Protection Project, Chicopee Falls, Mass.
Upstream View Along Railroad Embankment, from River Section 66+
Date: January 24, 1962
